D6-23622

The Influence of Microstructure
on the
Fracture Topography
of
Titanium Alloys

J. C. Williams, R. R. Boyer, and M. J. Blackburn

BOEING COMMERCIAL AIRPLANE DIVISION

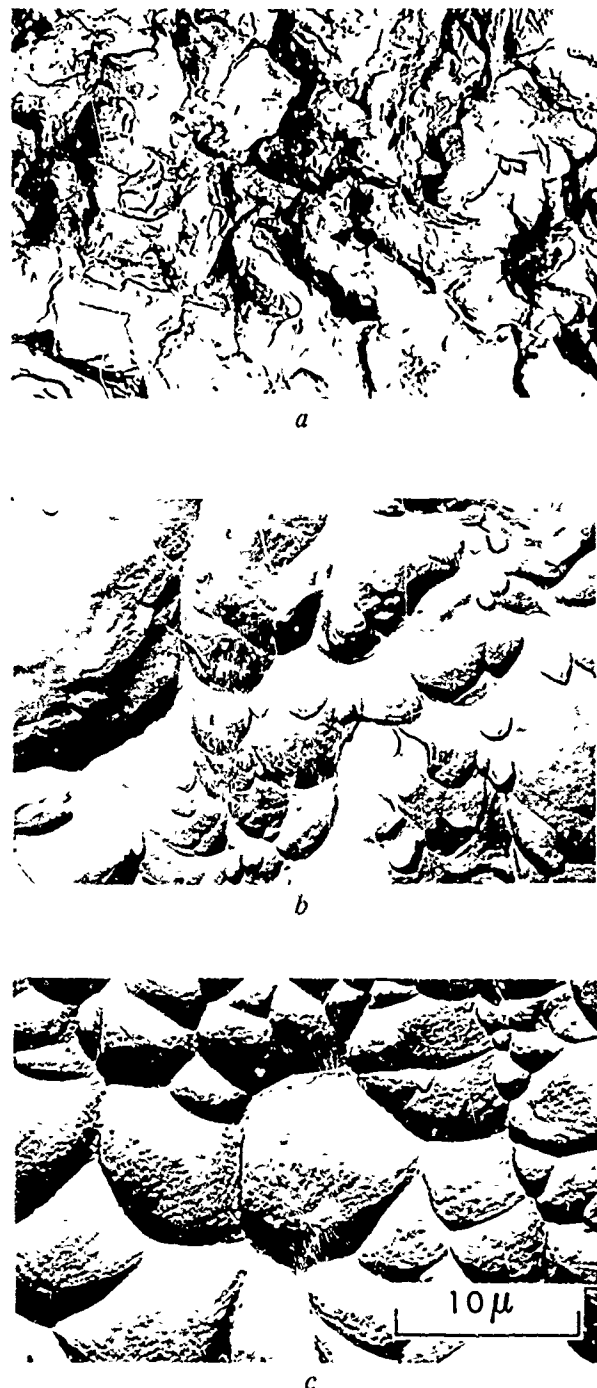
Figure 1. Examples of dimple rupture in the three categories of titanium alloys: (a) $\alpha+\beta$ alloy; Ti-8Al-1Mo-1V, (b) all- α alloy; Ti-5Al-2.5Sn, (c) all- β alloy; Ti-11.6Mo
3500 X

Ductile fracture of most α -, β -, and $\alpha+\beta$ -phase titanium alloys occurs by nucleation, growth, and coalescence of microvoids. Figure 1 is an example of this for each type of alloy. There is a correlation between decreasing dimple size and decreasing macroscopic ductility that is similar to that of other materials (1). This correlation can be shown in several alloys in which the flow and fracture behavior can be changed by heat treatment. Figures 2, 3, and 4 illustrate this trend for three different heat-treat conditions of each of three alloys. Similar trends may be seen when comparing the fracture surfaces of different alloys with the same phase structure but different mechanical properties. For example, compare Figures 2(a) and 3(b). In this example, the Ti-Mo and Ti-Mn alloys contain the ω phase on quenching; however, the dimple sizes observed do not correlate with the particle spacing. In fact, it is usually impossible to correlate dimple size in any alloy with any features observed using a microscope. In other alloys, e.g. iron- and aluminum-base alloys (2), many dimples contain features that are identified as inclusions or precipitates that act as void nucleation sites. Such features are almost never observed in titanium alloys, and thus the nucleation of voids is rather difficult to explain. The dimple size appears to be orientation dependent. A five-fold variation in dimple size between two adjacent α -phase grains is shown in Figure 5. These variations complicate absolute correlation between dimple size and macroscopic ductility.

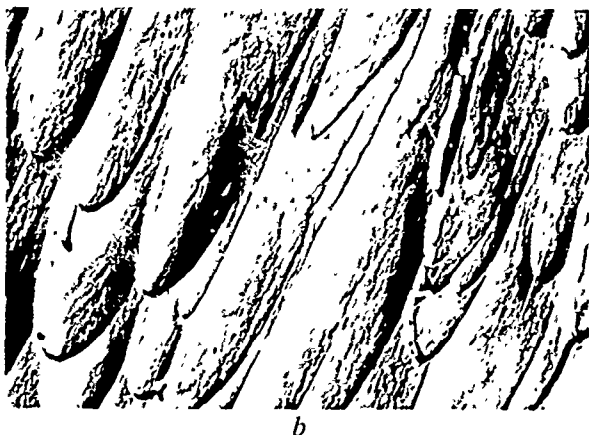
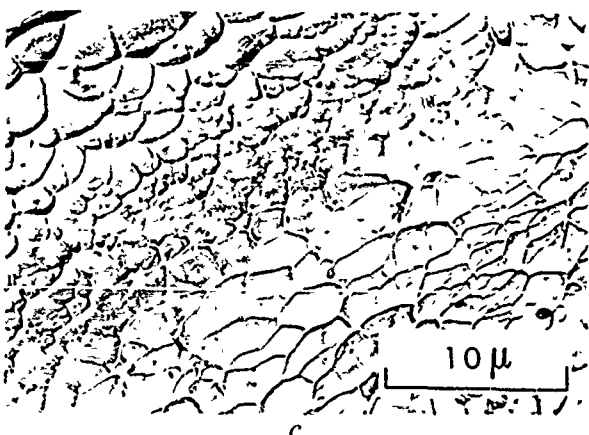
Figure 2. Correlation of dimple size and ductility in Ti-11.6Mo. Ductility decreases from: (a) all- β condition (70% elong.) to (b) α + β condition (14% elong.) to (c) β + ω condition (0% elong.). 3500 X

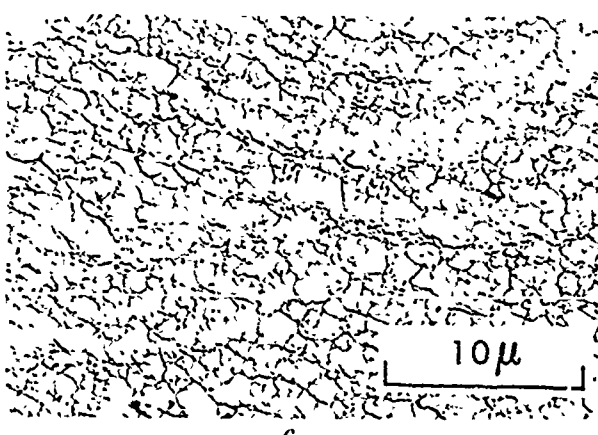
Figure 3. Correlation of dimple size and ductility in Ti-8Mn. Ductility decreases from (a) β + α condition (22% elong.) to (b) all- β condition (14% elong.) to (c) β + ω condition (0% elong.). 3500 X

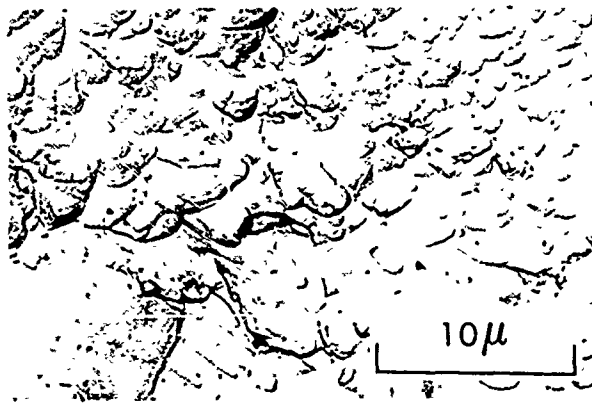
Figure 4. Correlation of dimple size and ductility in Ti-8Al. Ductility decreases from (a) solution treated at 950°C/W.Q. (~10% elong.) to (b) solution treated at 700°C/W.Q. (~5% elong.) to (c) solution treated at 600°C/W.Q. (~1-2% elong.) 3500 X

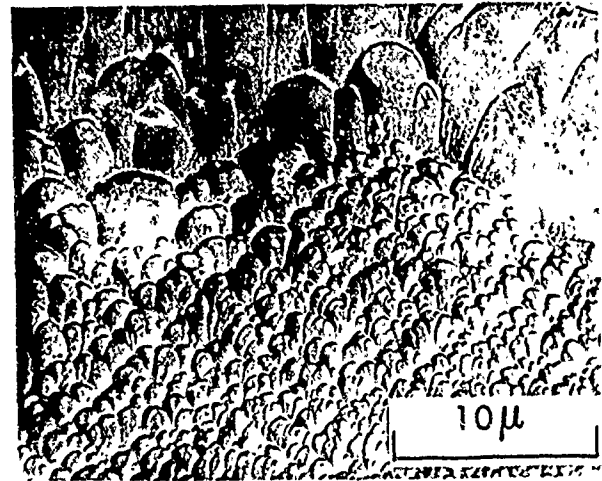
Figure 5. Orientation dependence of dimple size in Ti-8Al 3500 X

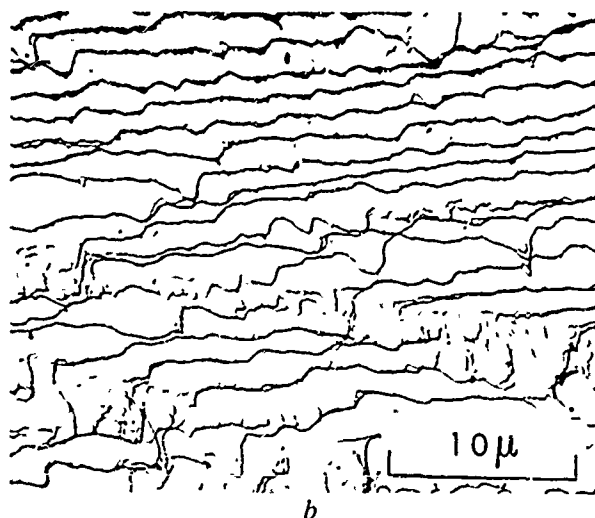
Figure 9. Very fine dimples observed fractographically in Ti-8Mn brittle failure.

Marked embrittlement of the β phase occurs if a large-volume fraction of small second-phase particles (either α or ω) is formed on aging at low temperatures. The ω phase is a transition precipitate that forms during low-temperature aging of metastable β -phase alloys, such as Ti-8Mn and Ti-11.6Mo, and the metastable β phase of a number of $\alpha+\beta$ -phase alloys. Specimens of Ti-Mo or Ti-Mn quenched from the β -phase field and subsequently aged at 400°C , to produce the ω -phase, exhibited essentially no macroscopic ductility. Specimens appeared by visual examination to have failed by cleavage as shown in Figure 8. Fractographic examination of these specimens, however, showed evidence of microscopic ductility in the form of small dimples as illustrated in Figure 9(a). Such features may have arisen through cracking on various levels and propagation of such microcracks toward the macroscopic crack. This type of fracture has been observed in plexiglass (8). However, the appearance of the dimples observed in Figure 9(a) is not consistent with this process, because these dimples appear to occur on a smooth fracture plane with a constant shape, whereas the dimples observed in plexiglass are randomly above and below the macroscopic fracture plane. Some fractures with a stepped appearance are observed in Ti-Mn alloys, and such steps suggest some crystallographic dependence of the fracture plane. Figure 9(b) shows an example of such a fracture.

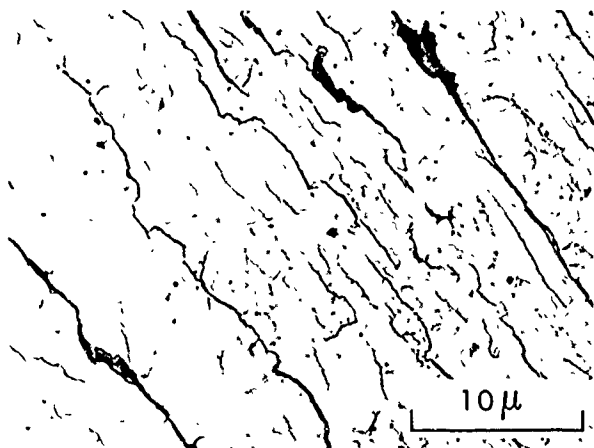
Figure 10. Stress-corrosion failure in a Ti-8Al notched specimen failed in 0.6MKI. 3500 X

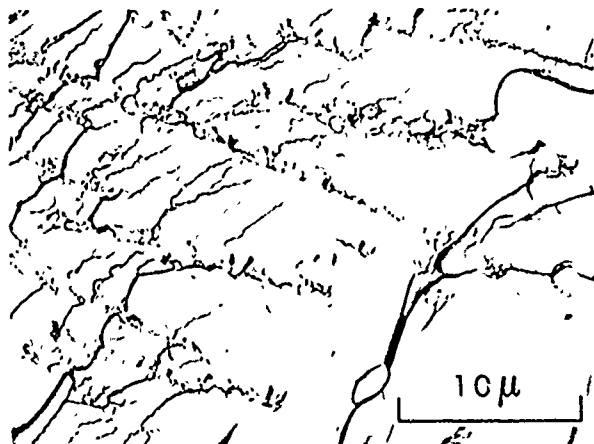
Figure 14. Stress-corrosion failure in Ti-8Mn illustrating cleavage in the β phase separated by bands of α that failed in a more ductile manner in 0.6M KCl. 3500 X

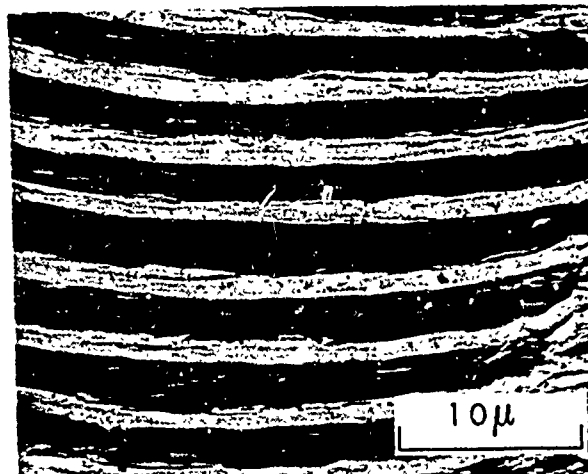
Figure 15. Ductile fatigue striations in (a) Ti-8Al (all- α alloy) and (b) Ti-13V-11Cr-3Al (all- β alloy). 3500 X

Only a very limited number of observations on fatigue failure are included here. Fatigue crack propagation in α -, β -, and $\alpha+\beta$ -phase alloys is accompanied by development of fatigue striations present in other alloys (2,11). The striations that occur in the α -phase alloys appear to be strongly orientation dependent, often changing directions markedly when the crack front crosses a grain boundary. Figures 15(a) and 15(b) show the striations observed in α - and β -phase alloys. In brittle Ti-Al alloys aged to produce α_2 and in β -phase alloys aged to produce ω , crack propagation under cyclic loading occurs by cyclic propagation of a crack that extends a large distance in each stress cycle. Fractographic examination shows fractures produced under these conditions appear to be identical to the brittle tensile fractures described previously.
